UNDERWATER BRIDGE INSPECTION REPORT

STRUCTURE NO. 4237

BUFFALO RIVER

DISTRICT 4 - CLAY COUNTY

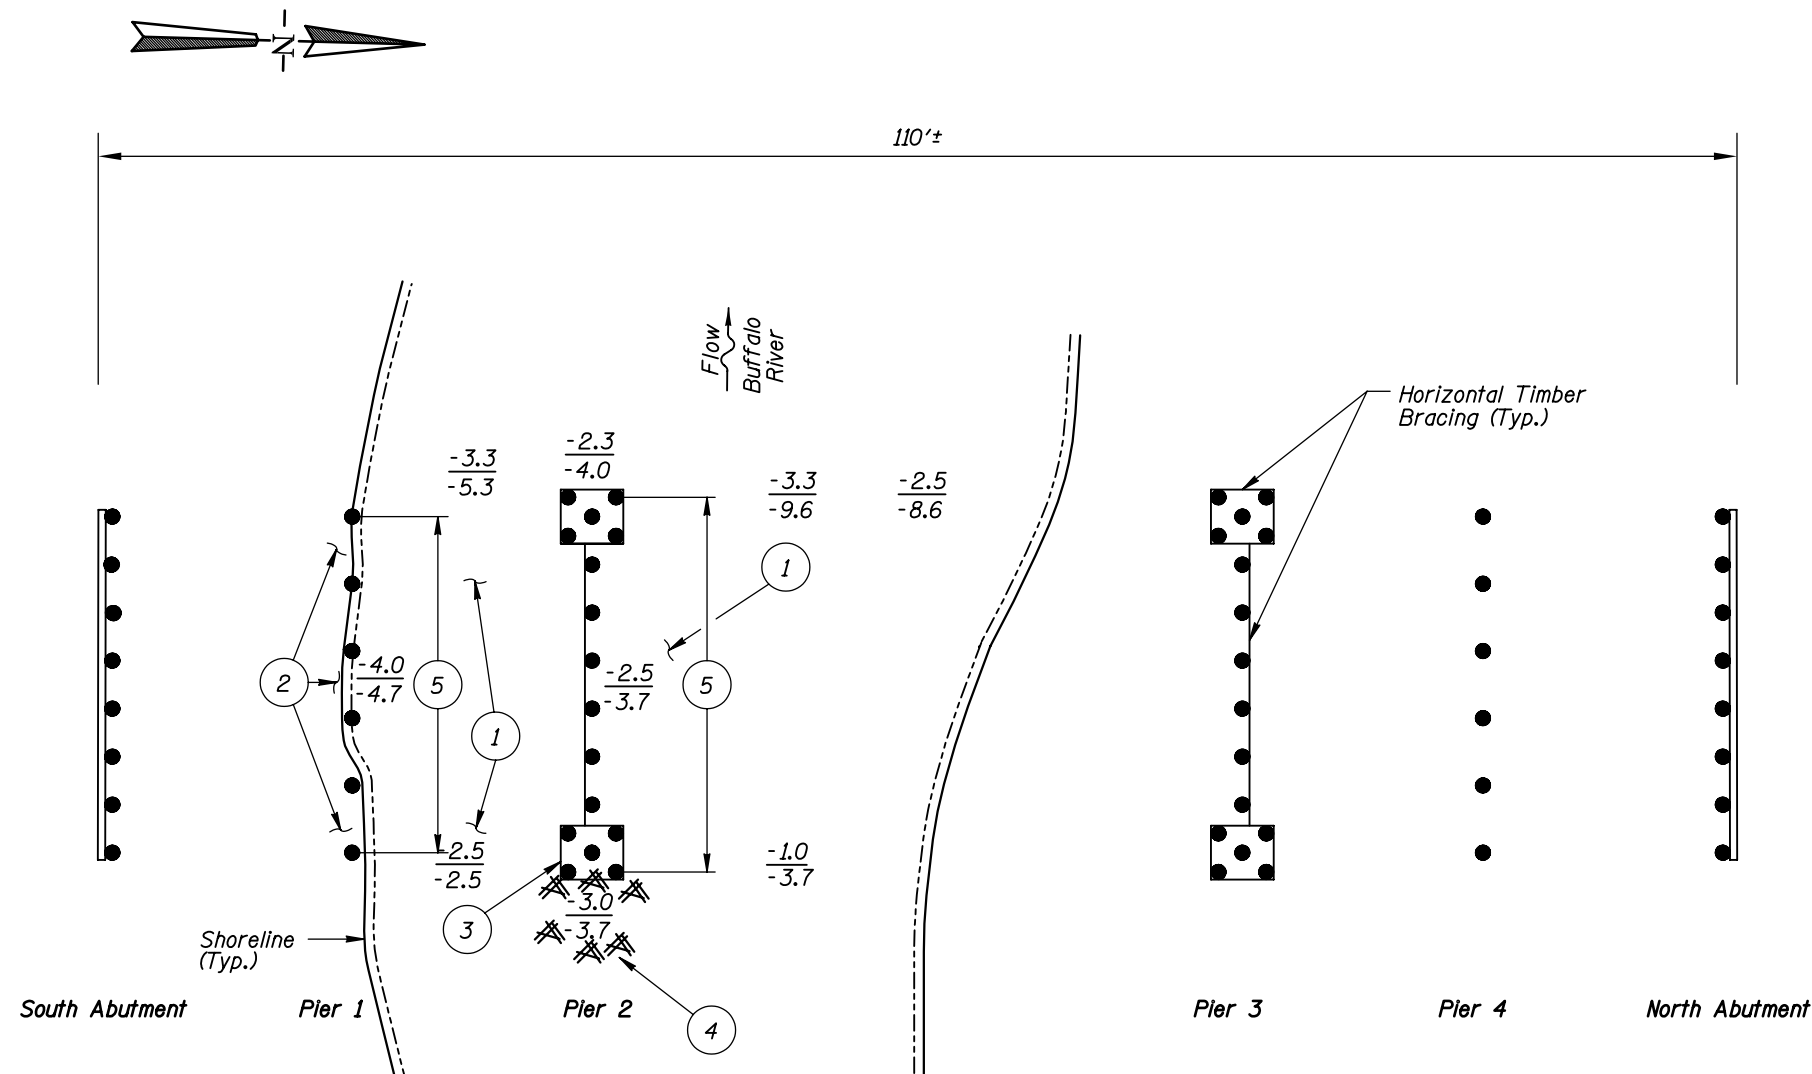
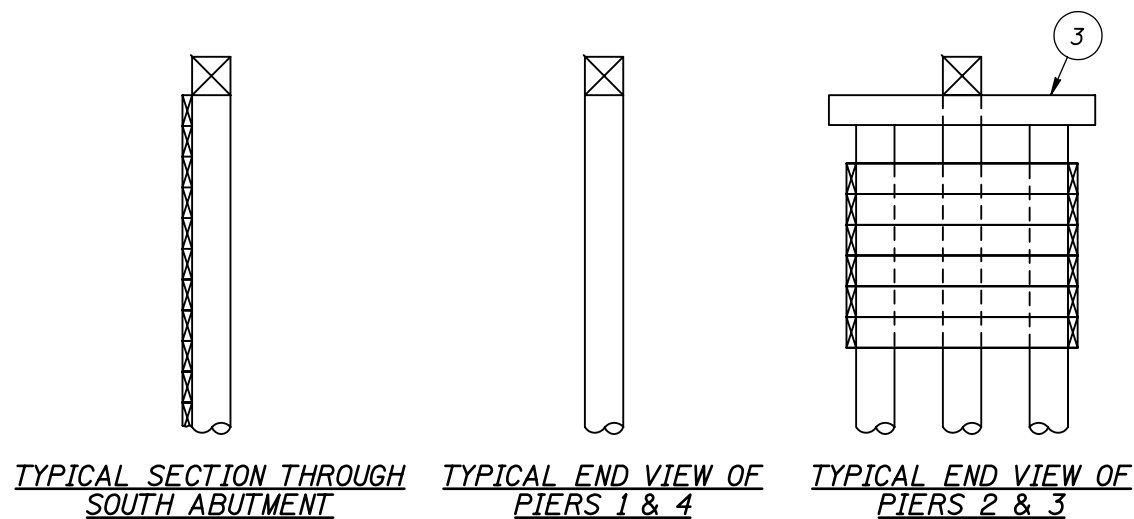
INSPECTION AND SOUNDING PLAN

- 1 The channel bottom consisted of silt with a maximum probe rod penetration of 1.5 feet.
- 2 The shoreline was armored with a 3 foot strip of riprap up to 1 foot in diameter.
- 3 The transverse cap beam at the upstream end of Pier 2 has been replaced with a new timber beam.
- 4 A light accumulation of timber debris, with pieces up to 8 inches in diameter, was observed at the upstream end of Pier 2.
- 5 Overall, the timber piles were in good condition with no structurally significant defects observed.
